**FIFTH FIVE-YEAR REVIEW REPORT FOR
GENERAL MOTORS (CENTRAL FOUNDRY DIVISION) SUPERFUND SITE
FRANKLIN COUNTY, NEW YORK**

**U.S. Environmental Protection Agency
Region 2
New York, New York**

This is the fifth FYR for the General Motors (Central Foundry Division) (GM) Superfund site (Site). The triggering action for this statutory review is the September 30, 2020, signature date of the previous FYR report. The FYR has been prepared because hazardous substances, pollutants or contaminants remain at the Site above levels that allow for unlimited use and unrestricted exposure (UU/UE).

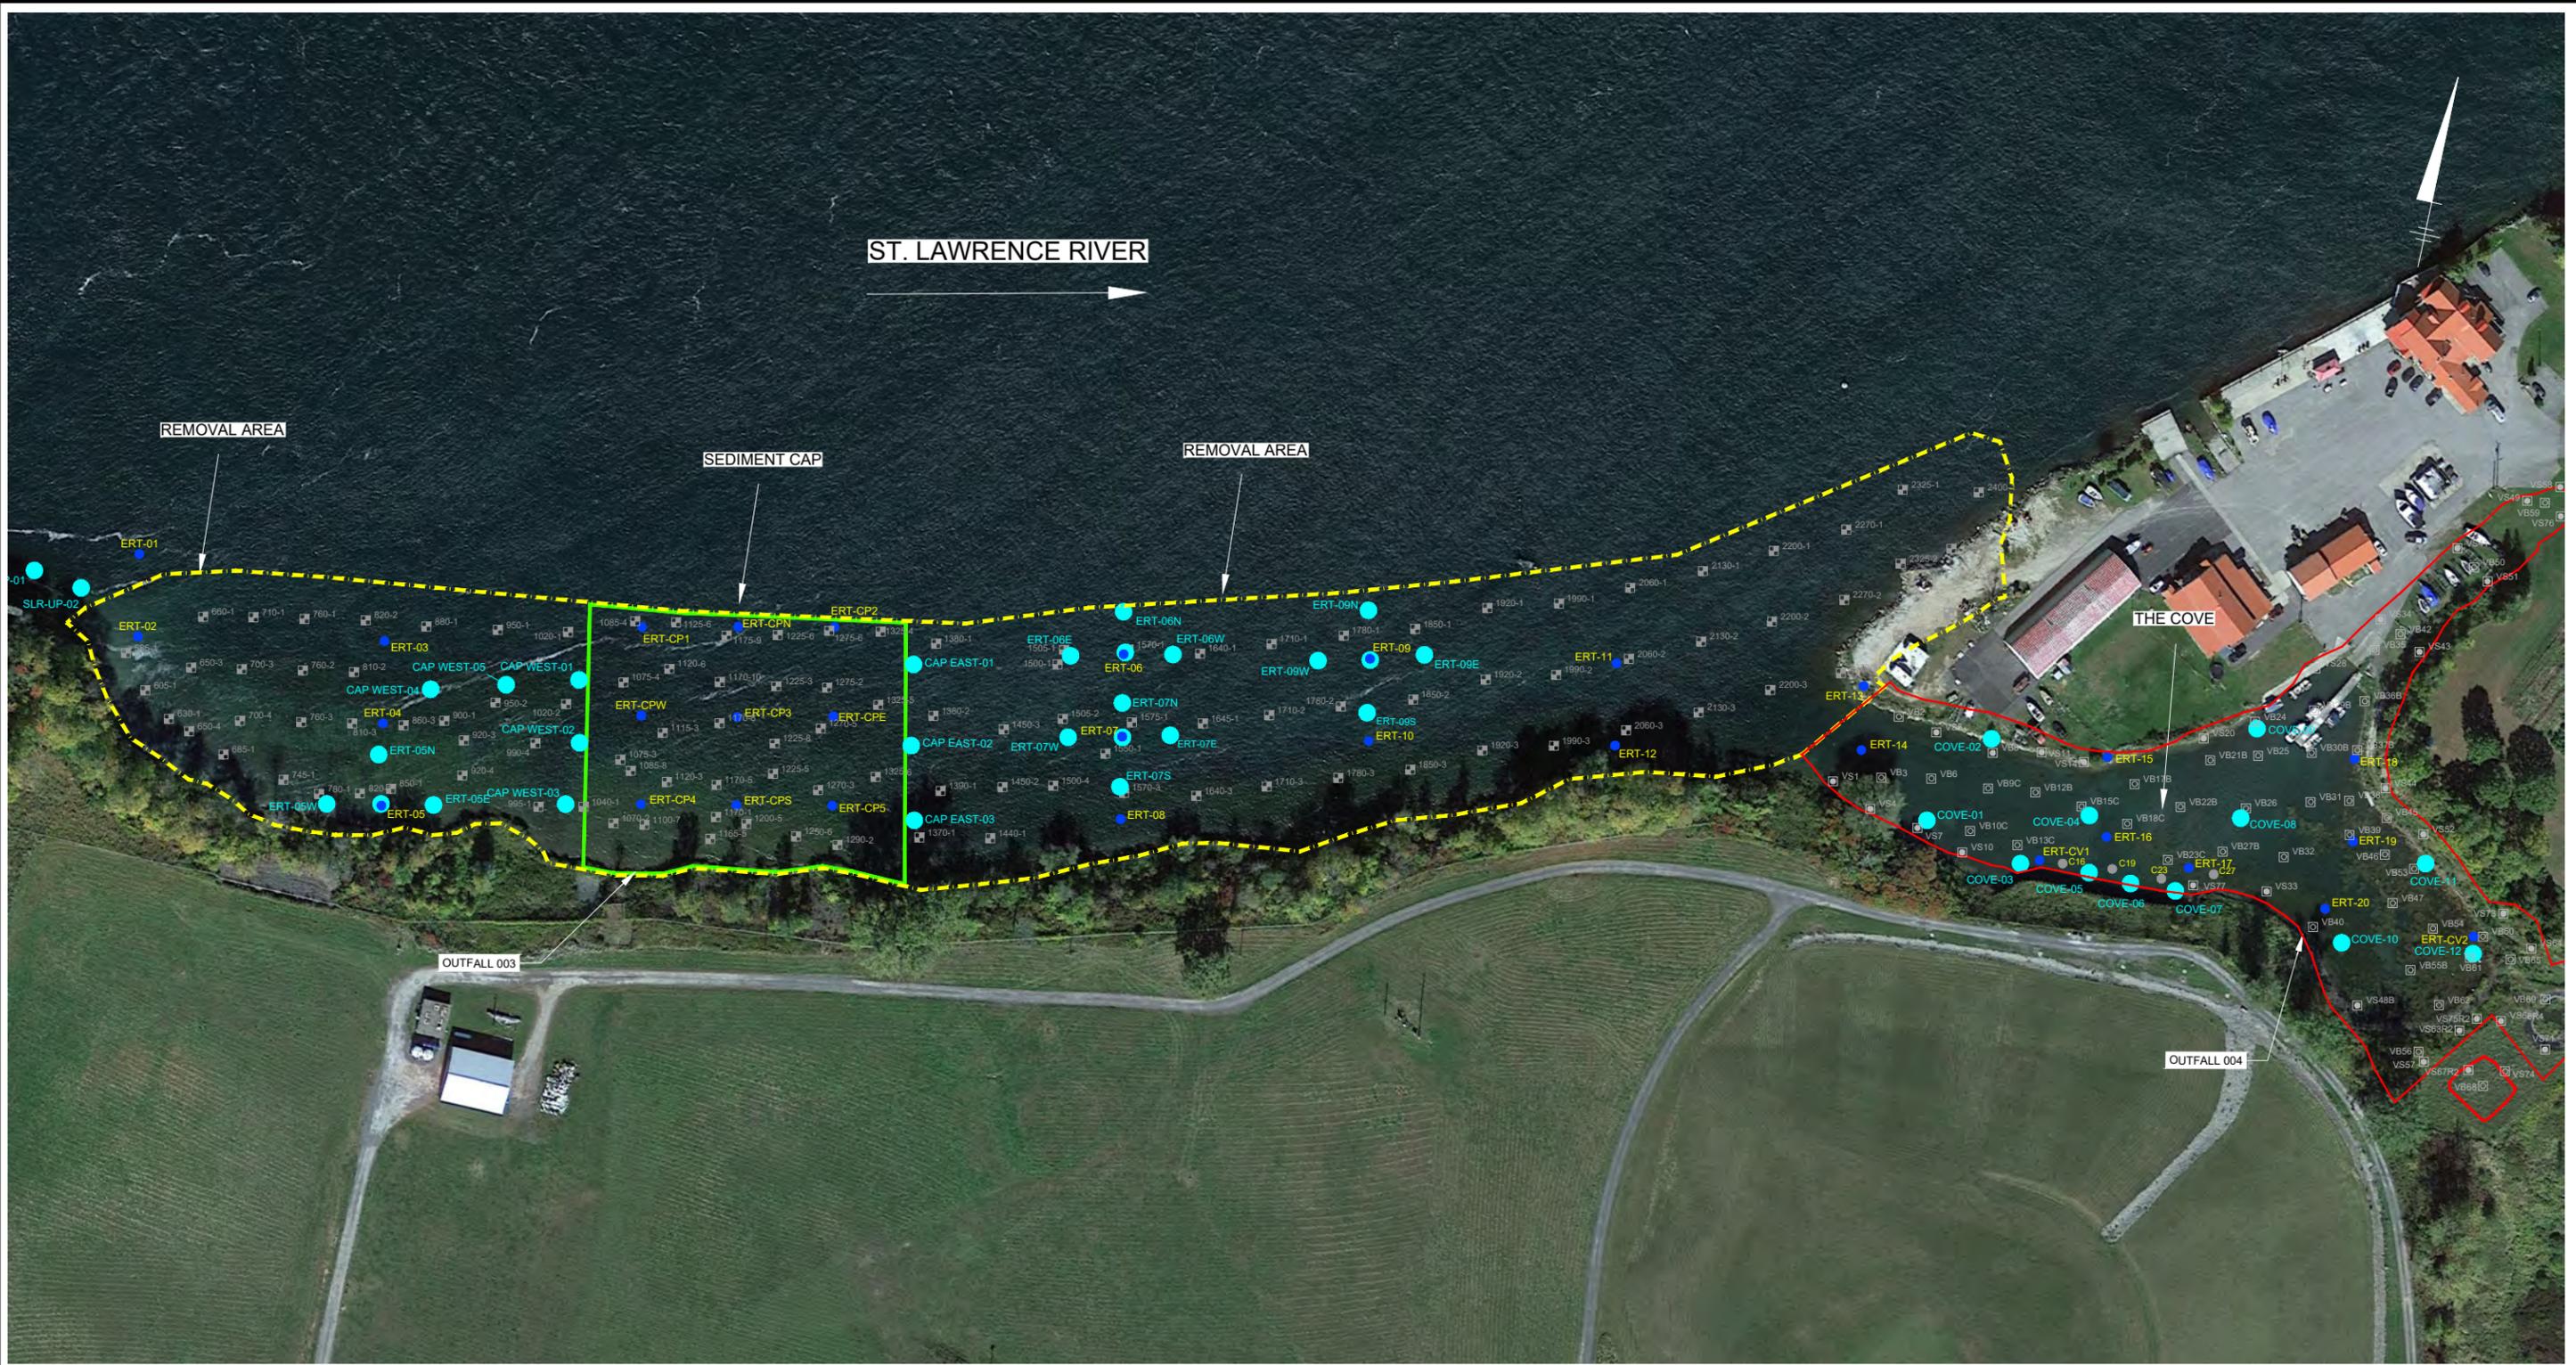
FIGURE
3

- ERT-CP5 2019 SEDIMENT SAMPLE LOCATION
- SEDIMENT REMOVAL AREA
- SEDIMENT CAP AREA
- ERT-05W 2023 SEDIMENT SAMPLE LOCATION
- COVE REMEDIATION LIMITS

Total PCB concentrations detected at the 2023 sample locations within the Cove, with concentrations compared against the ROD-established 0.1 mg/kg cleanup criteria are found in **Appendix A, Table 4 and Figure 6**. Total PCB concentrations exceeding the 0.1 mg/kg cleanup criteria were detected at six of the 12 sampling locations and in a total of 14 of 40 sample intervals. The highest total PCB concentration detected in Turtle Cove (3.39 mg/kg) was in the 0 to 6-inch interval of soft sediment collected at location Cove-07, which is adjacent to the sheet pile wall. In the overlying soft sediments of Turtle Cove, the mean concentration of the 21 samples collected was 0.37 mg/kg. Six (29%) of the 21 samples exceed the 0.1 mg/kg criteria.

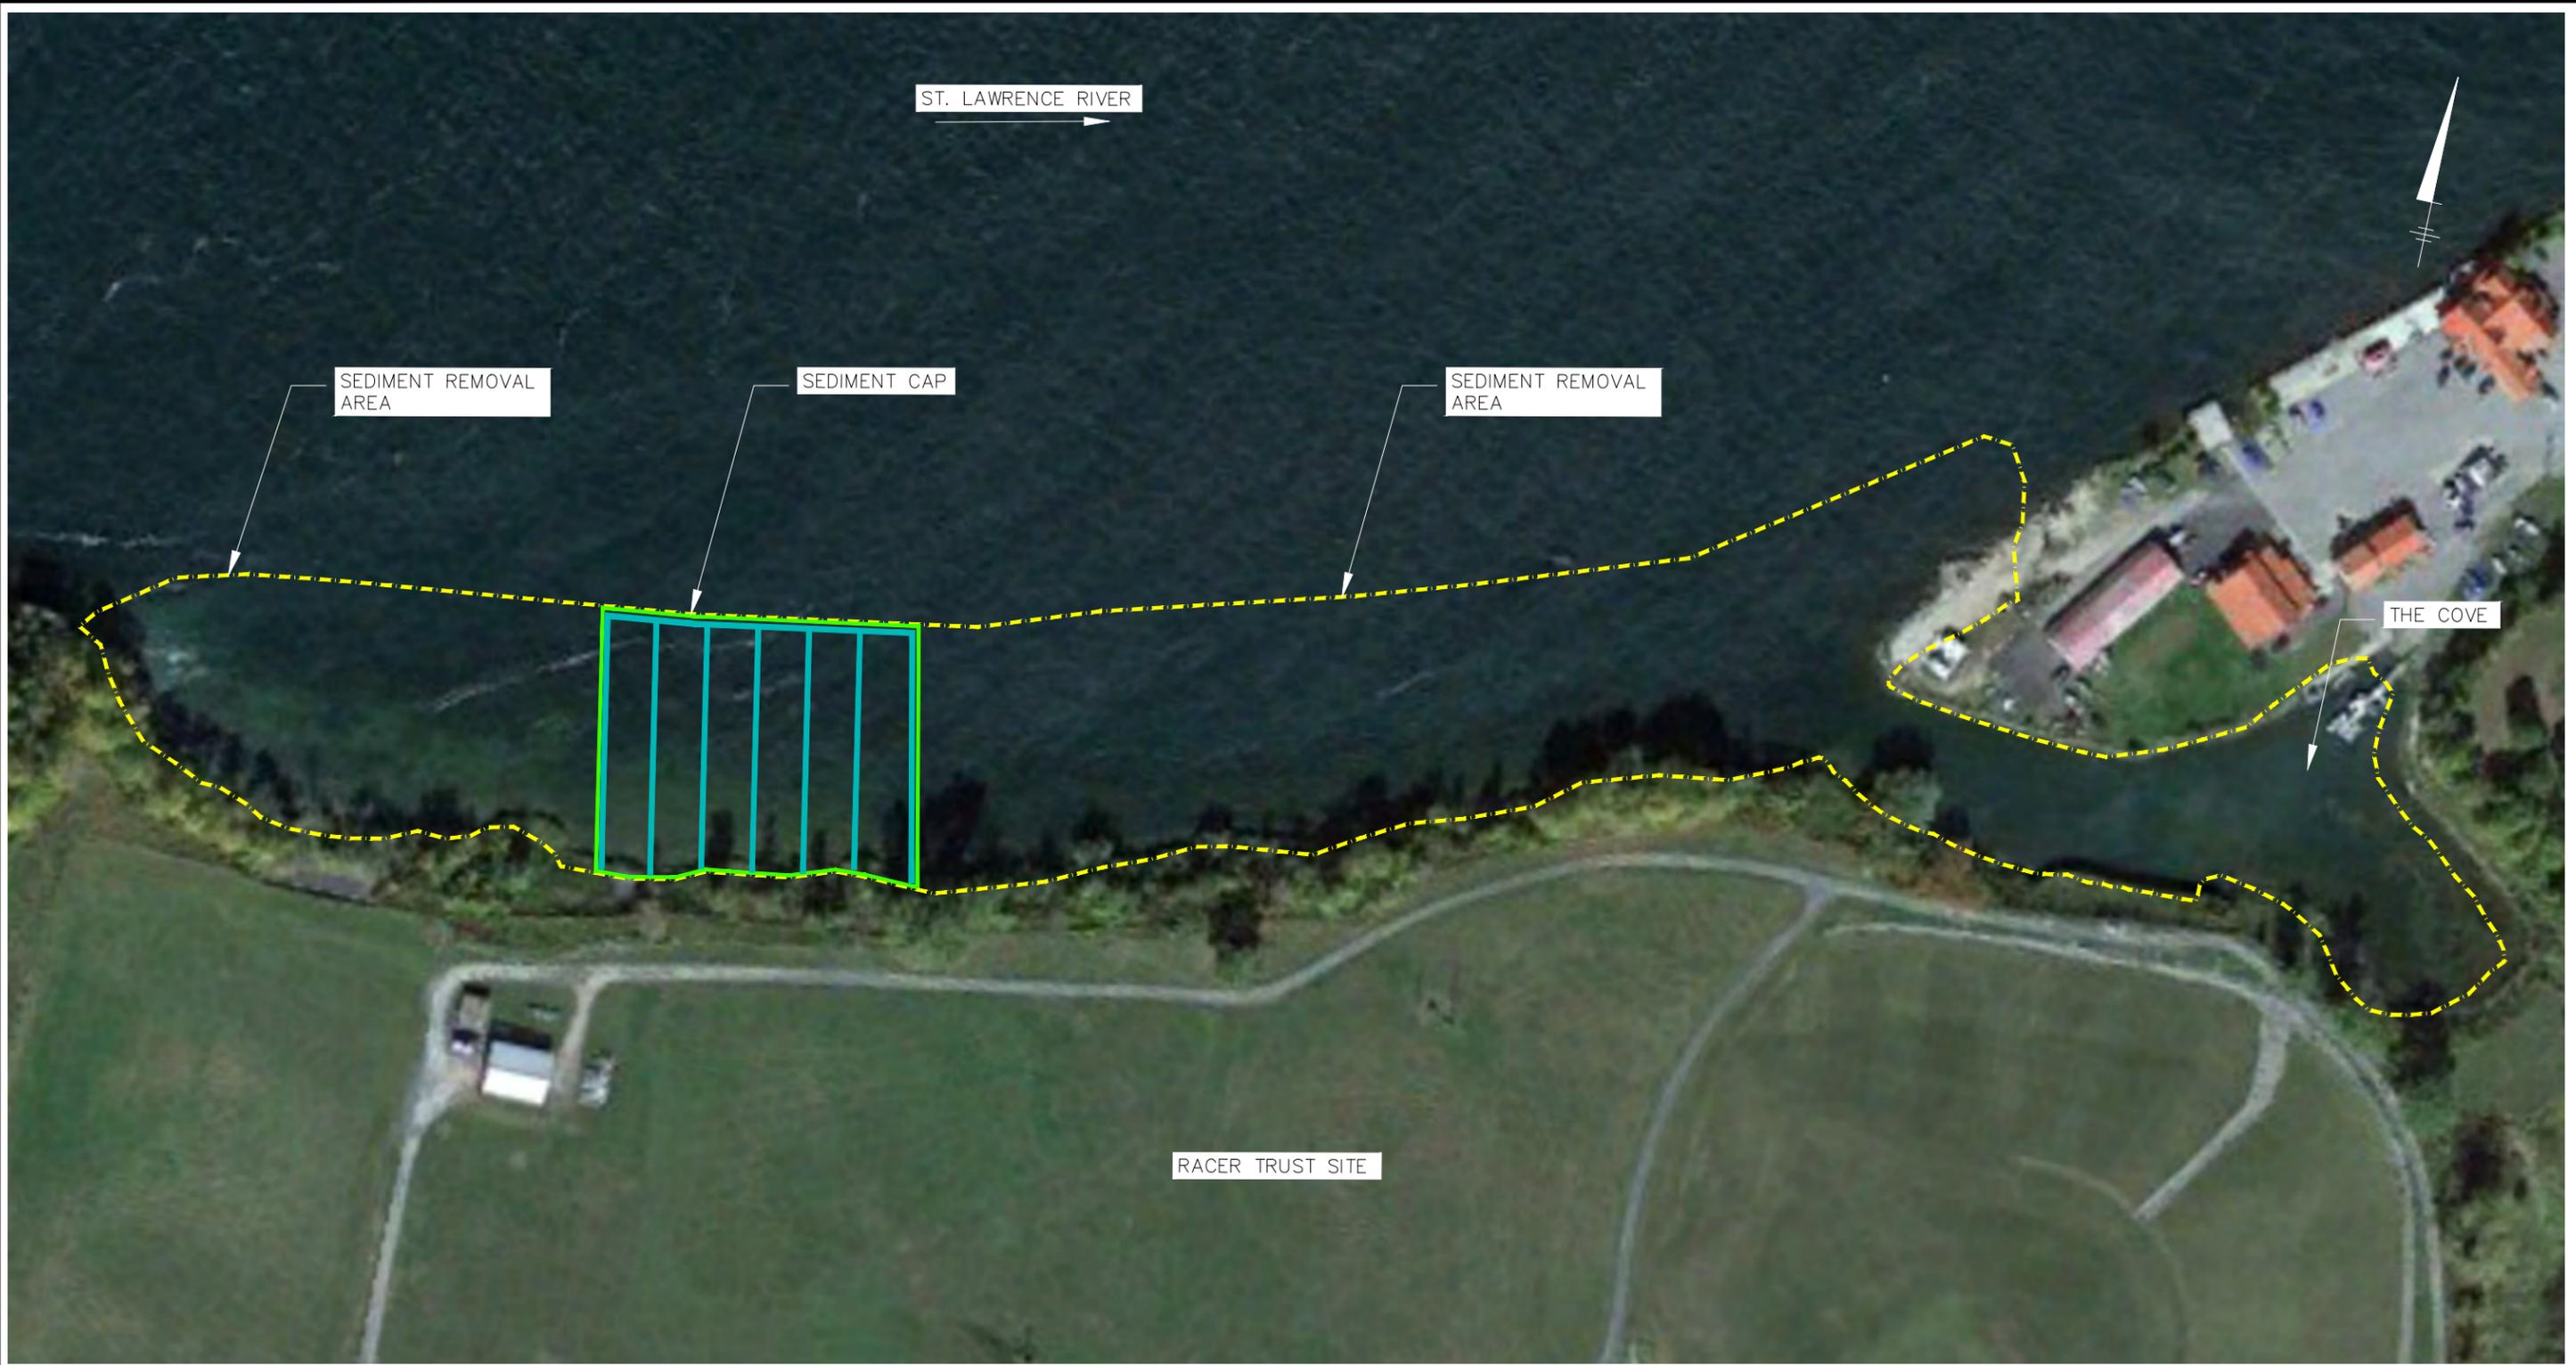
**FIGURE
 5**

SEDIMENT REMOVAL AREA

SEDIMENT CAP

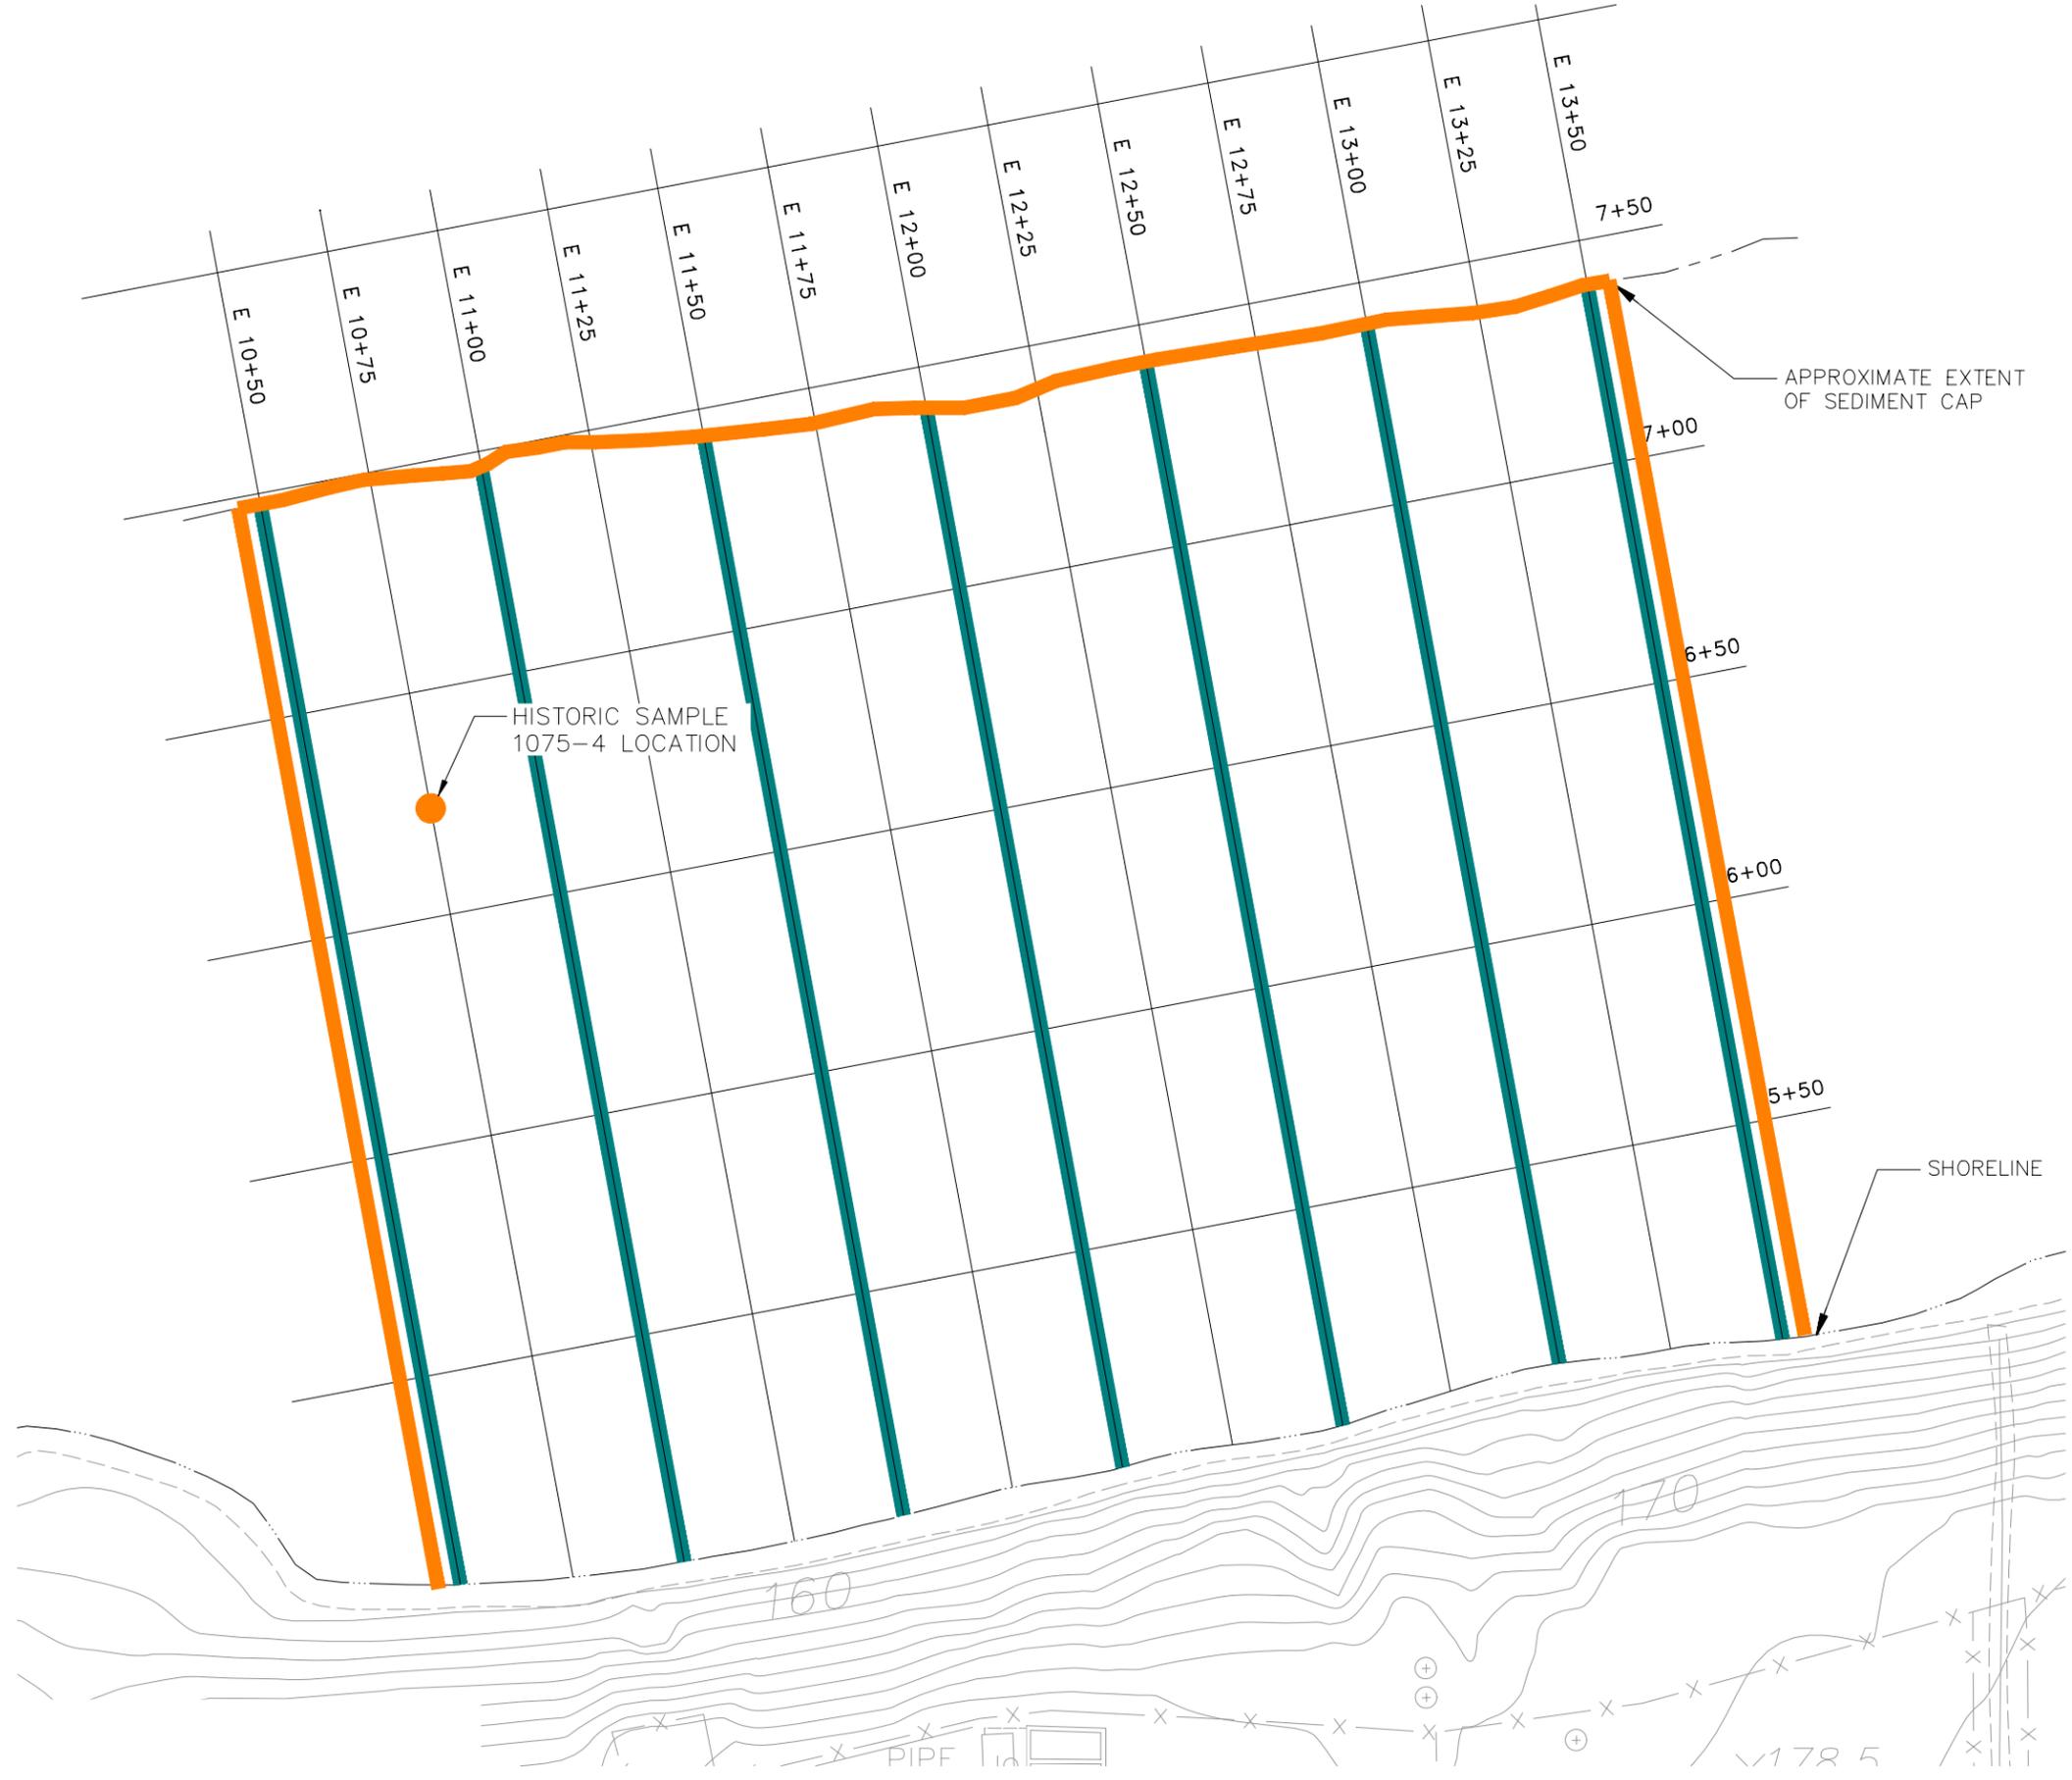
FIGURE
 7

- E 13+50 INSPECTION TRANSECT STATION (EASTERLY)
- TRANSECTS VISUALLY INSPECTED BY DIVERS
- X FENCE
- ADDITIONAL INSPECTION AREA

A physical inspection of the subaqueous SLR Cap was conducted on June 27th, and 28th 2023 by RACER consultants Arcadis, and the EPA Environmental Response Team (ERT) dive team, using an underwater video camera. Both a vegetation survey and cap inspection were performed. Based on the observations made during the 2023 vegetation survey and sediment cap inspection, the SLR sediment cap appears to be intact with no visual deficiencies or anomalies identified (**Appendix A, Figures 7 and 8**).

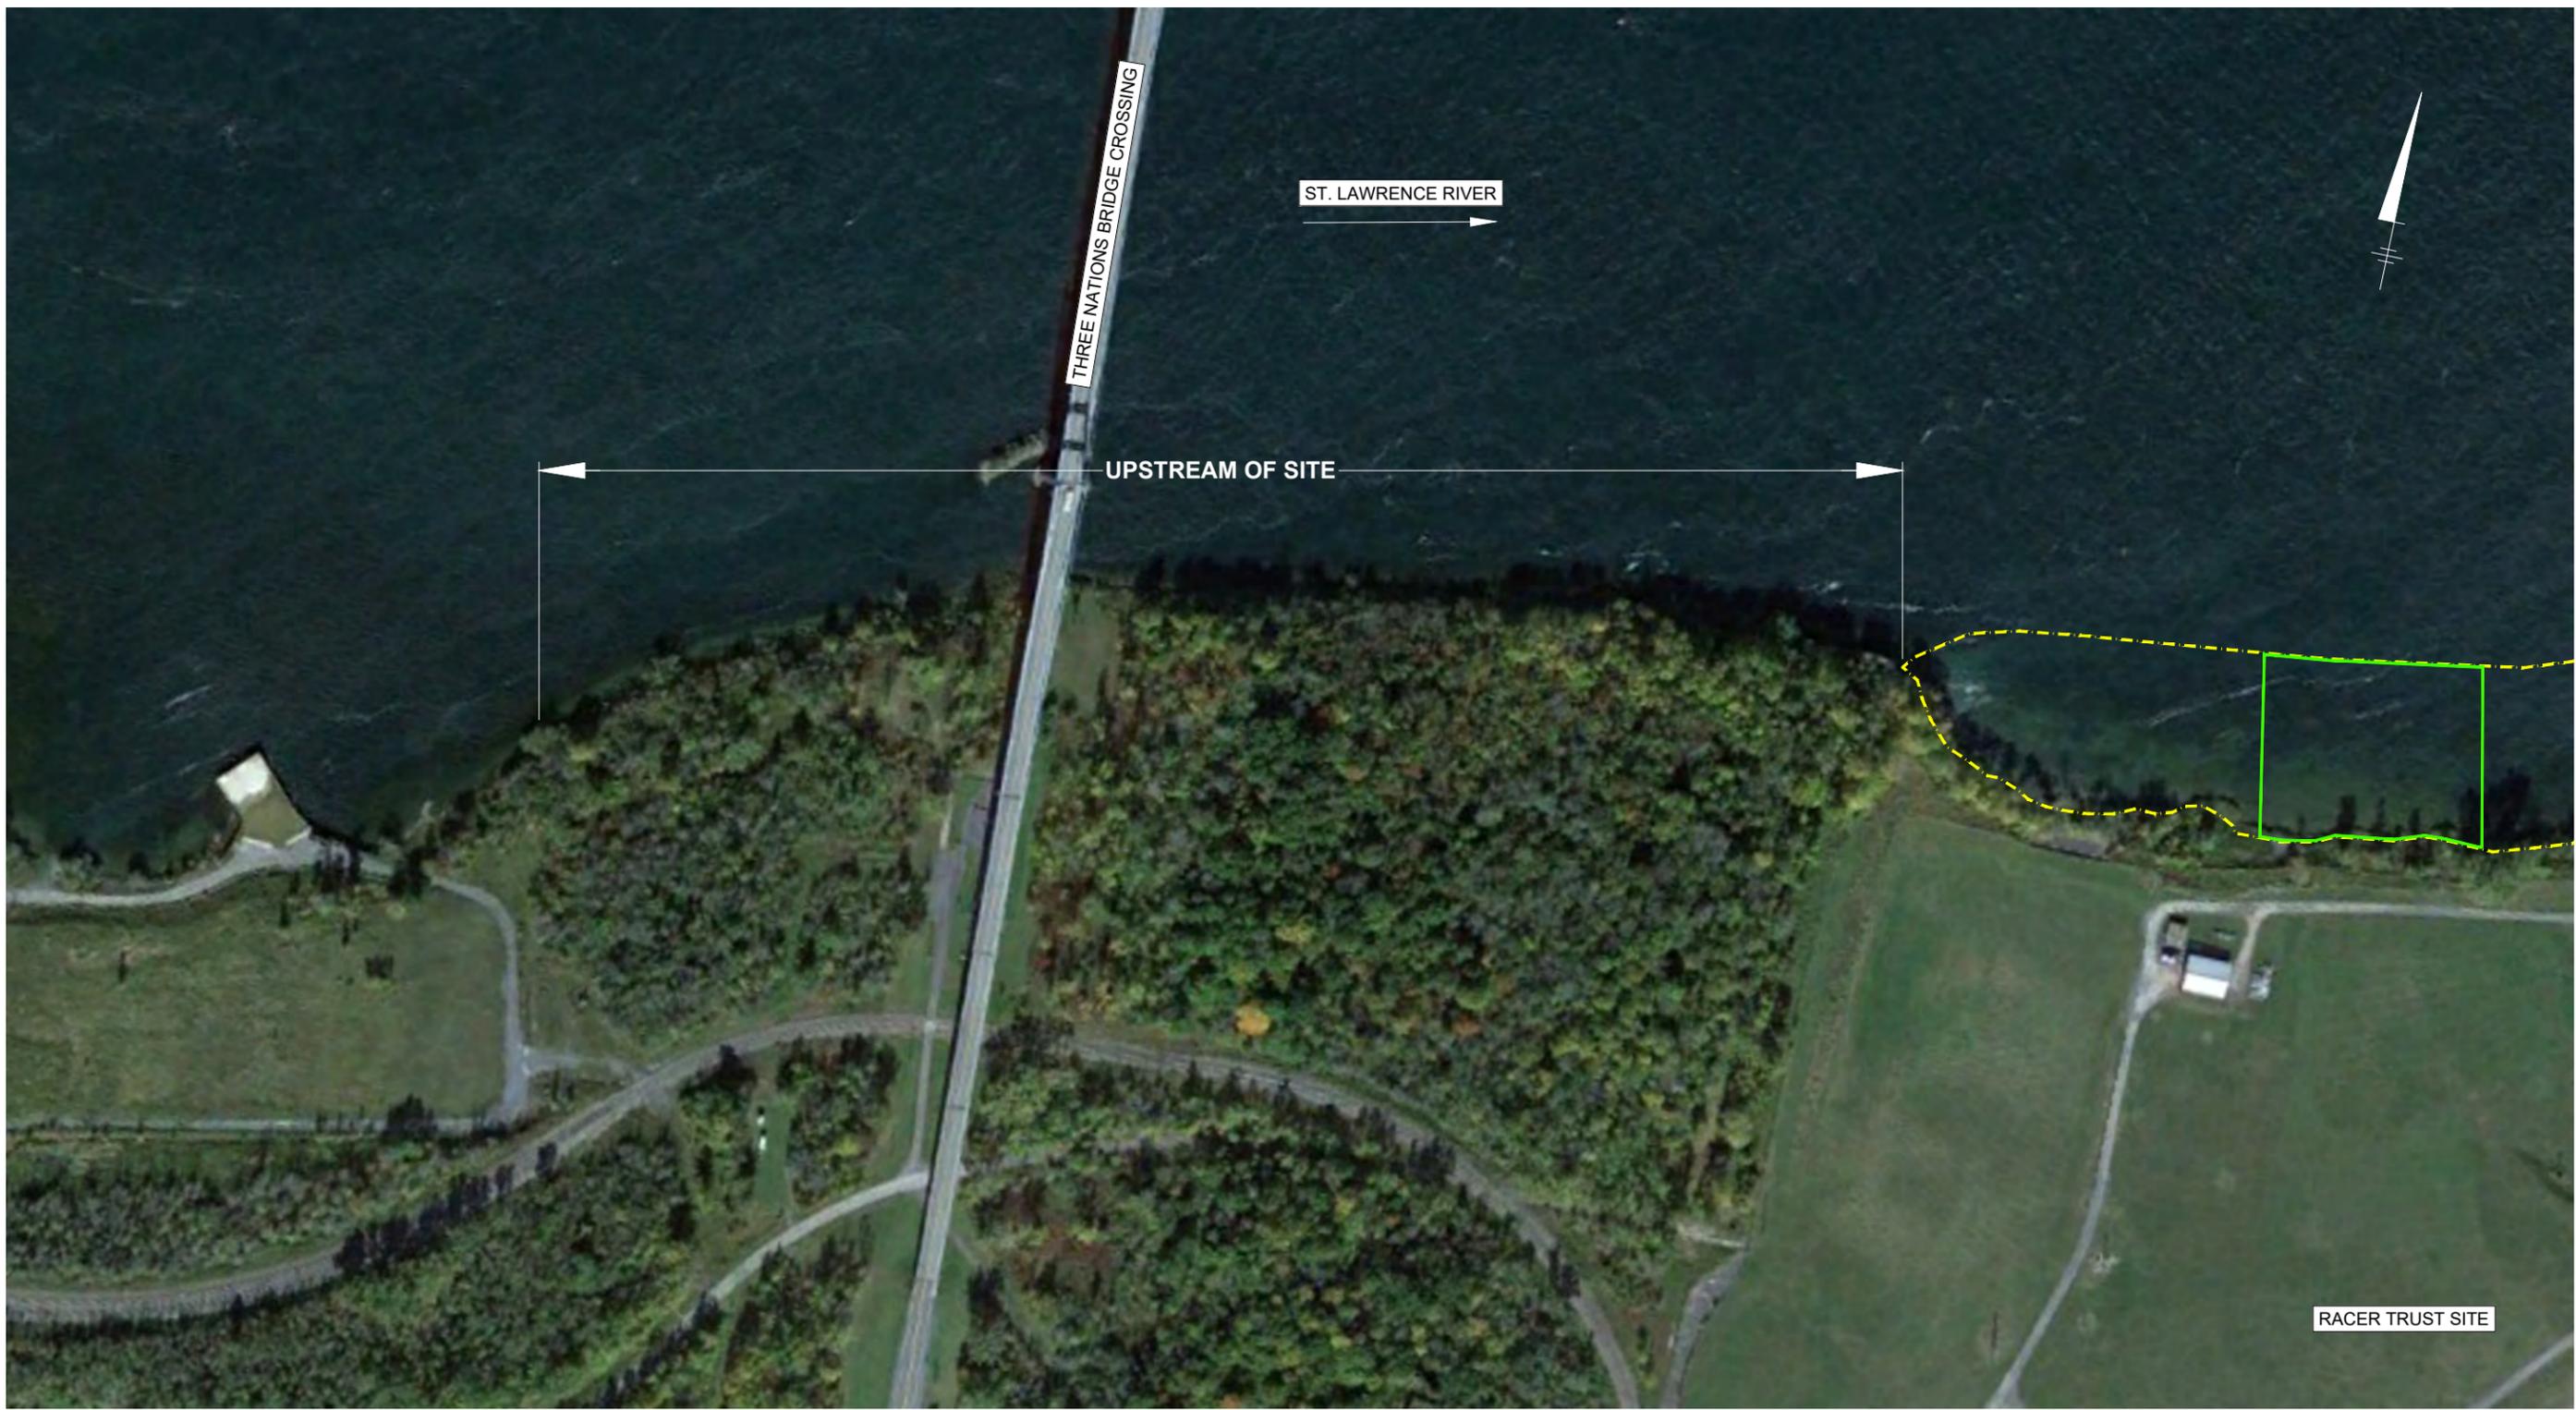
**FISH SAMPLING AREAS
 SITE WIDE**

LEGEND:
 - - - - - SEDIMENT REMOVAL AREA
 _____ SEDIMENT CAP

1. Sample areas are shown on Figure 1; Approximate fish collection locations are shown on Figures 2, 3, and 4.
2. Smallmouth bass were targeted as the predatory fish species; walleye were collected as a substitute species for smallmouth bass when unavailable.

1. Sample areas are shown on Figure 1; Approximate fish collection locations are shown on Figures 2, 3, and 4.
2. Spottail shiner were targeted as the young-of-year fish species; round goby were collected as a substitute species for spottail shiner when unavailable.
3. All samples were processed as whole-body composites and analyzed for PCB Aroclors and percent lipids.
4. Lipid-normalized PCB concentrations were calculated using half the detection limit for sample results that were non-detect.
5. External anomalies, if present, were noted in the field.

1. Sample areas are shown on Figure 1. From 1997 through 2022, young-of-year fish were collected from locations across each sampling area; the sample results are representative of fish captured within each sample area rather than at individual locations. In 2024, young-of-year fish were collected from location-specific areas within each sample area, as shown on Figures 2, 3, and 4.

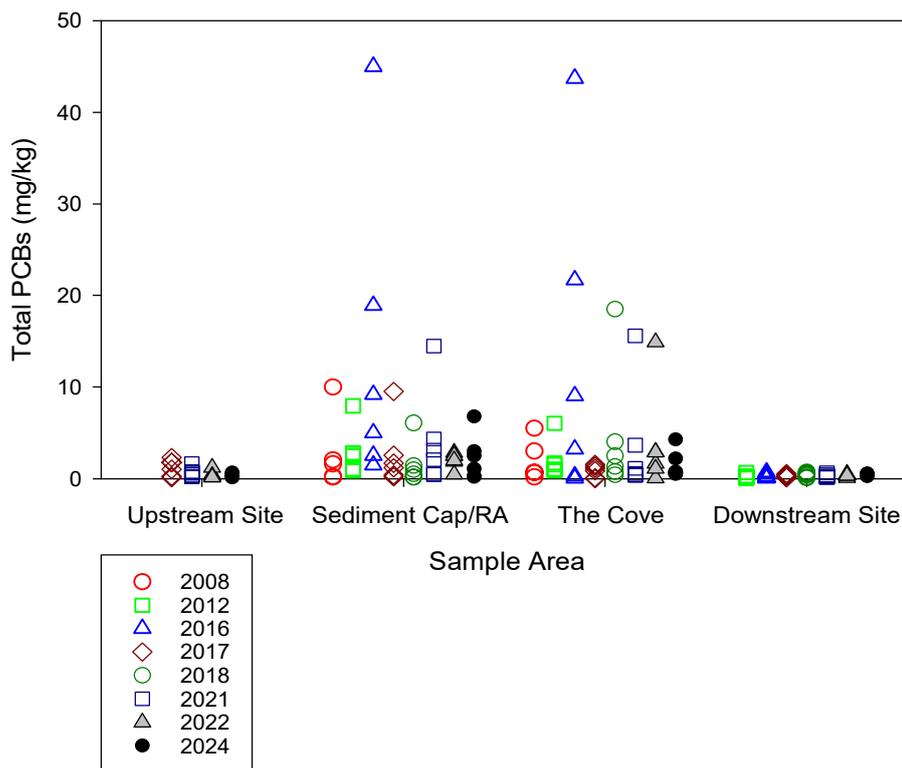
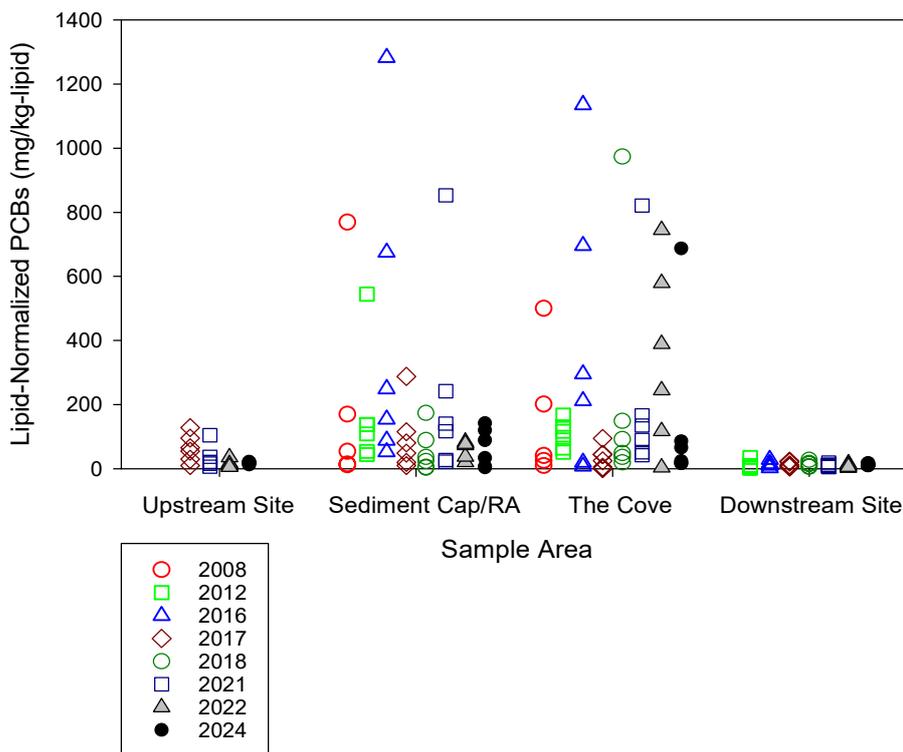
Predatory Fish

1. Smallmouth bass were targeted as the predatory fish species; largemouth bass or walleye were collected as a substitute species for smallmouth bass when unavailable.
2. All adult fish samples were processed as individual NYSDEC standard filets and analyzed for PCB Aroclors and percent lipids.
3. Sample results shown above are total PCB and lipid-normalized PCB wet-weight concentrations.
4. Data are shown for years fish were collected at a particular sample area; not all sample areas were targeted each collection year.

The mean total PCB concentrations in predatory fish have remained consistent with the exception of the 2016 sampling event, which had elevated PCB levels for undetermined reasons. Since 2016, the mean fish tissue concentrations have remained relatively consistent for Downstream, Sediment Cap/Removal Area, and the Turtle Cove, with no clear trend. Upstream of the Site were the lowest results observed for predatory fish since sampling began there in 2017.

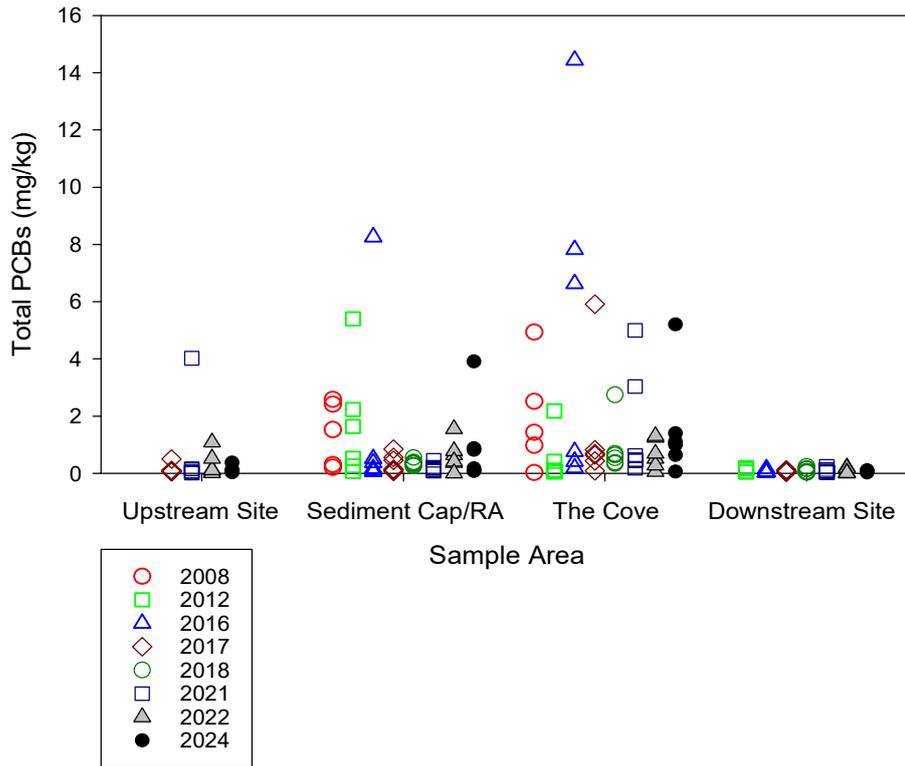
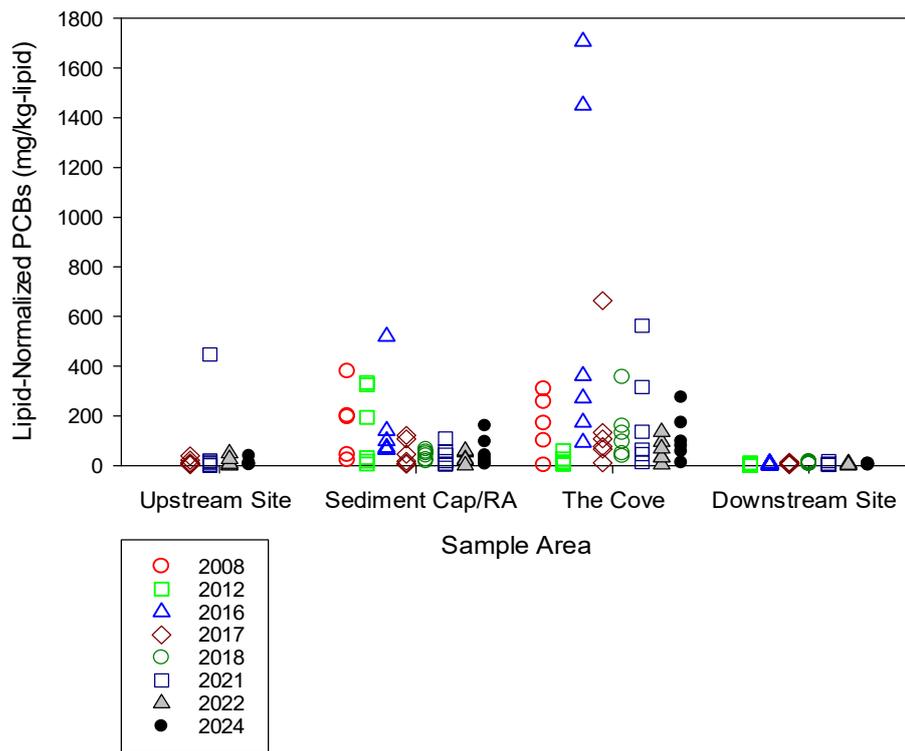
Bottom-Feeding Fish

1. Brown bullhead were targeted as the bottom-feeding fish species; white sucker were collected as a substitute species for brown bullhead when unavailable.
2. All adult fish samples were processed as individual NYSDEC standard filets and analyzed for PCB Aroclors and percent lipids.
3. Sample results shown above are total PCB and lipid-normalized PCB wet-weight concentrations.
4. Data are shown for years fish were collected at a particular sample area; not all sample areas were targeted each collection year.

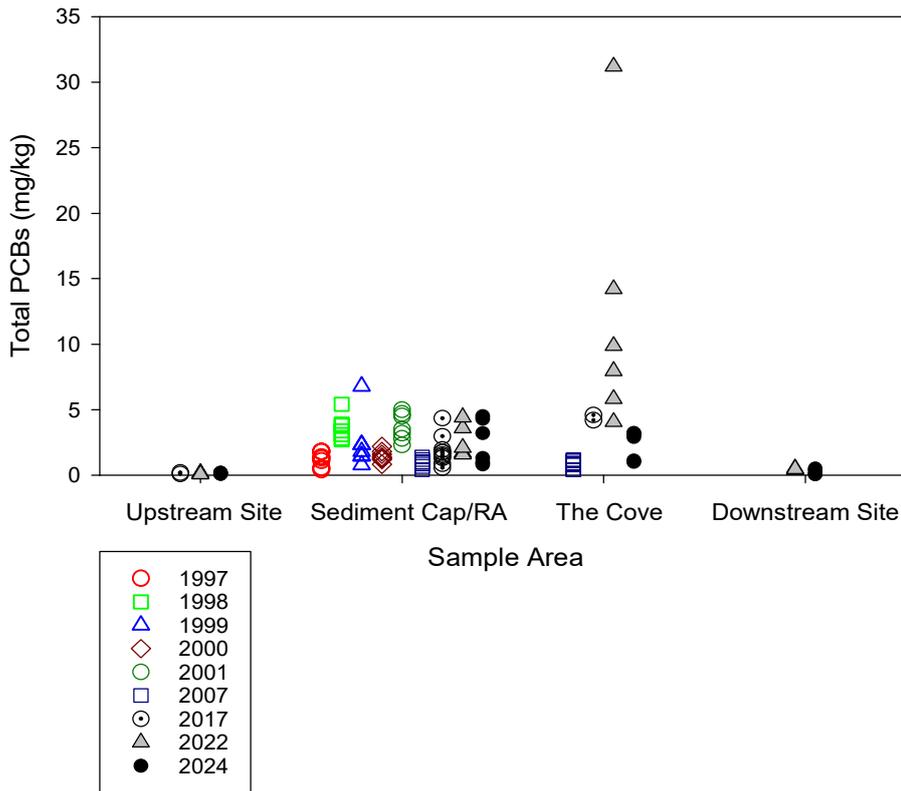
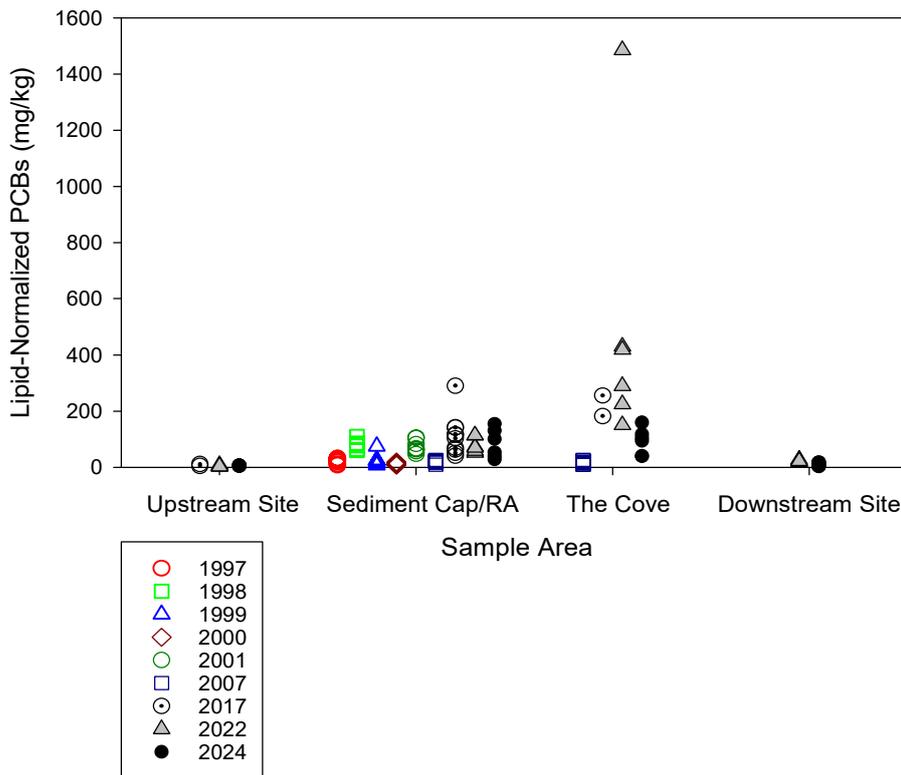
Young-of-Year Fish

1. Spottail shiner were targeted as the young-of-year fish species; round goby were collected as a substitute species for spottail shiner when unavailable.
2. All young-of-year fish samples were processed as whole-body composites and analyzed for PCB Aroclors and percent lipids.
3. Sample results shown above are total PCB and lipid-normalized PCB wet-weight concentrations.
4. Data are shown for years fish were collected at a particular sample area; not all sample areas were targeted each collection year.

YOY sampled in 2022 and 2024 during this review period had the same mean concentration in the Sediment Cap/Removal Area (2.5 mg/kg) for both years, whereas there was a decrease in mean concentration for the Turtle Cove from 2022 (12 mg/kg) to 2024 (2.4 mg/kg). The 2024 mean in the Cove is the lowest observed since 2007 and was a similar mean concentration to the 2024 SLR YOY. The 2022 and 2024 YOY mean total PCB results in the Sediment Cap/Removal Area and Turtle Cove remain higher than the YOY fish PCB in the upstream and downstream locations. The Cove had higher mean PCB concentrations than the Sediment Cap/Removal area in 2017 and 2022, but decreased to slightly below
