**FIFTH FIVE-YEAR REVIEW REPORT FOR
GENERAL MOTORS (CENTRAL FOUNDRY DIVISION) SUPERFUND SITE
FRANKLIN COUNTY, NEW YORK**

**U.S. Environmental Protection Agency
Region 2
New York, New York**

This is the fifth FYR for the General Motors (Central Foundry Division) (GM) Superfund site (Site). The triggering action for this statutory review is the September 30, 2020, signature date of the previous FYR report. The FYR has been prepared because hazardous substances, pollutants or contaminants remain at the Site above levels that allow for unlimited use and unrestricted exposure (UU/UE).

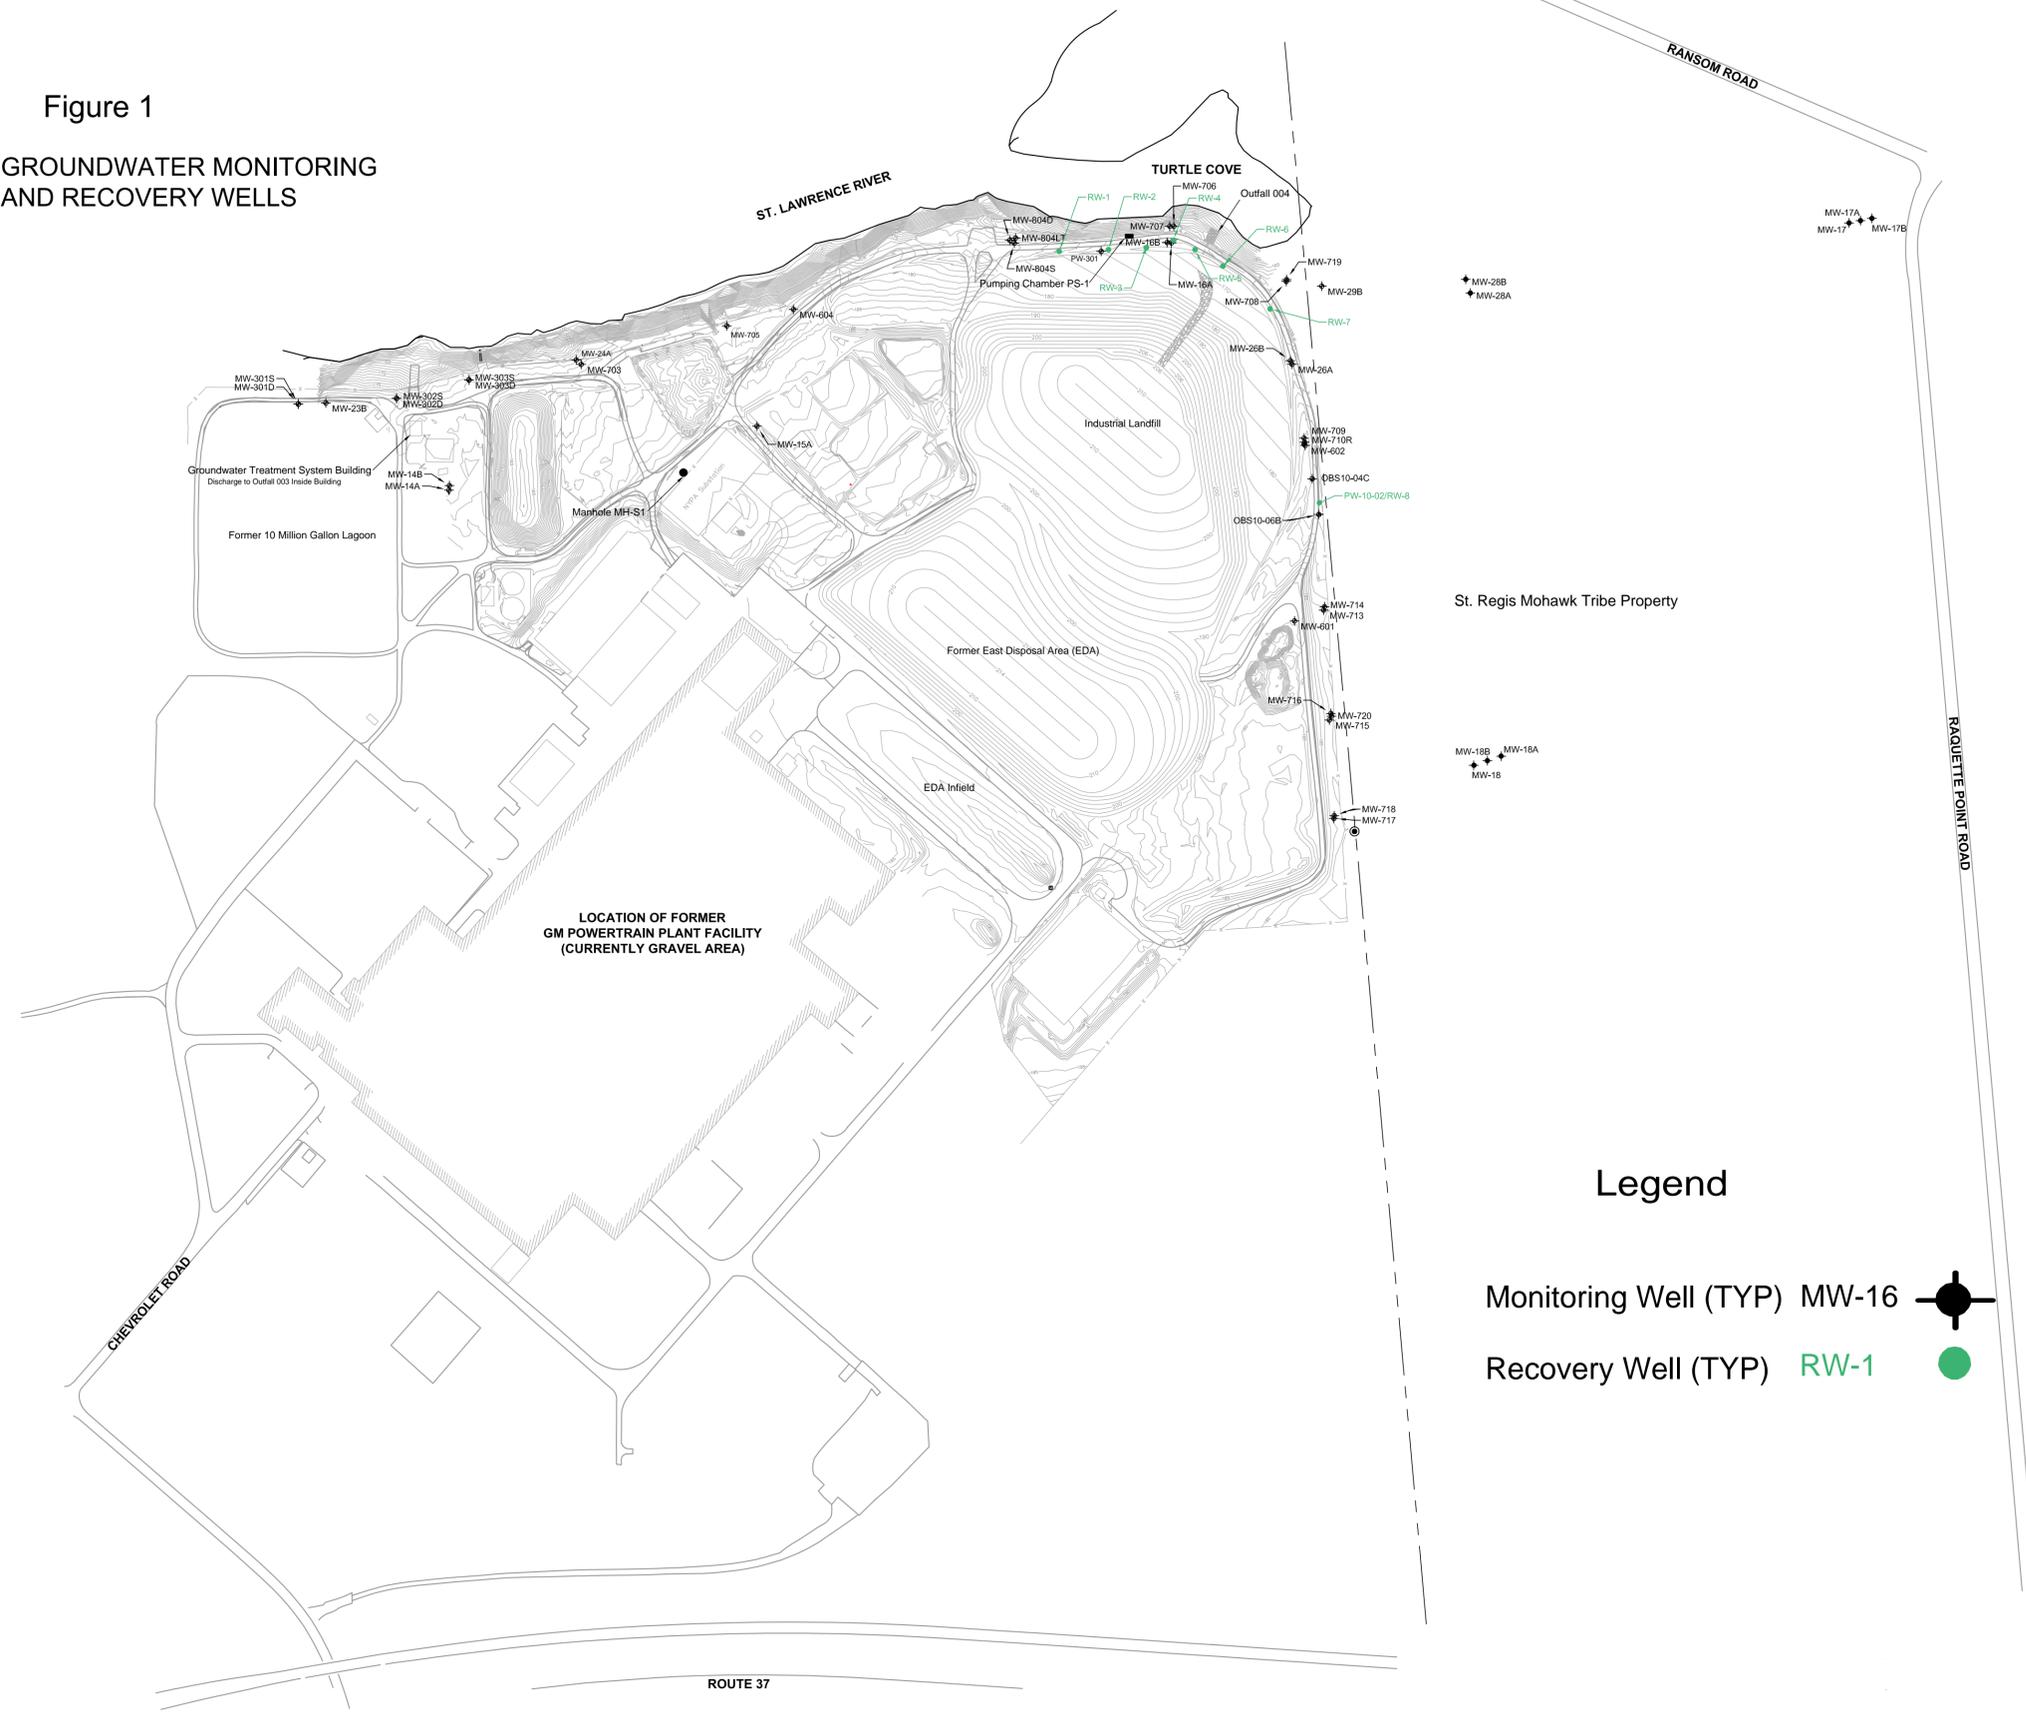
Figure 1
GROUNDWATER MONITORING
AND RECOVERY WELLS

- Monitoring Well (TYP) MW-16
- Recovery Well (TYP) RW-1
